# **DISASTER RISK MANAGEMENT IN DEVELOPING COUNTRIES AND THE IMPORTANCE OF INTERNATIONAL COOPERATION**

**Julio KUROIWA<sup>1</sup>**

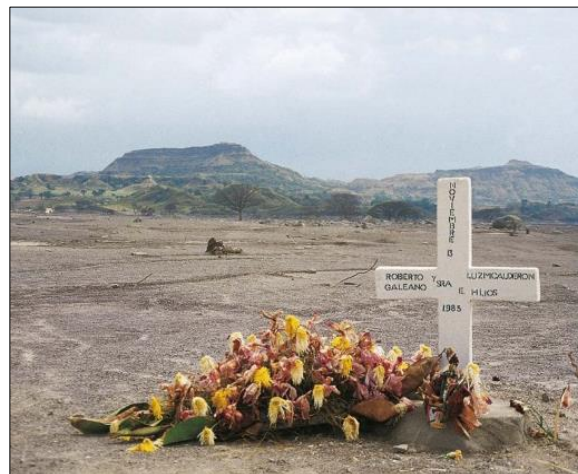
Fig. 2b. Downtown Armero where thousands of people resided before the volcanic disaster. Photo taken by the author in January 1986.

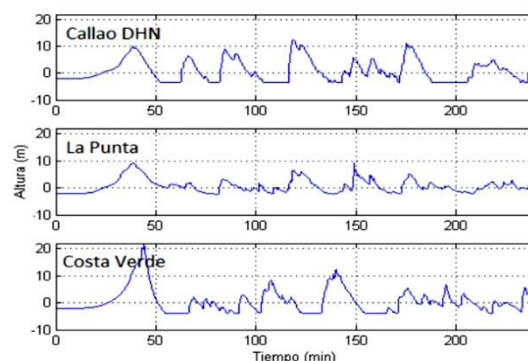
Fig. 4. Simulated tsunami waves. Courtesy of Dr. Cesar Jimenez.

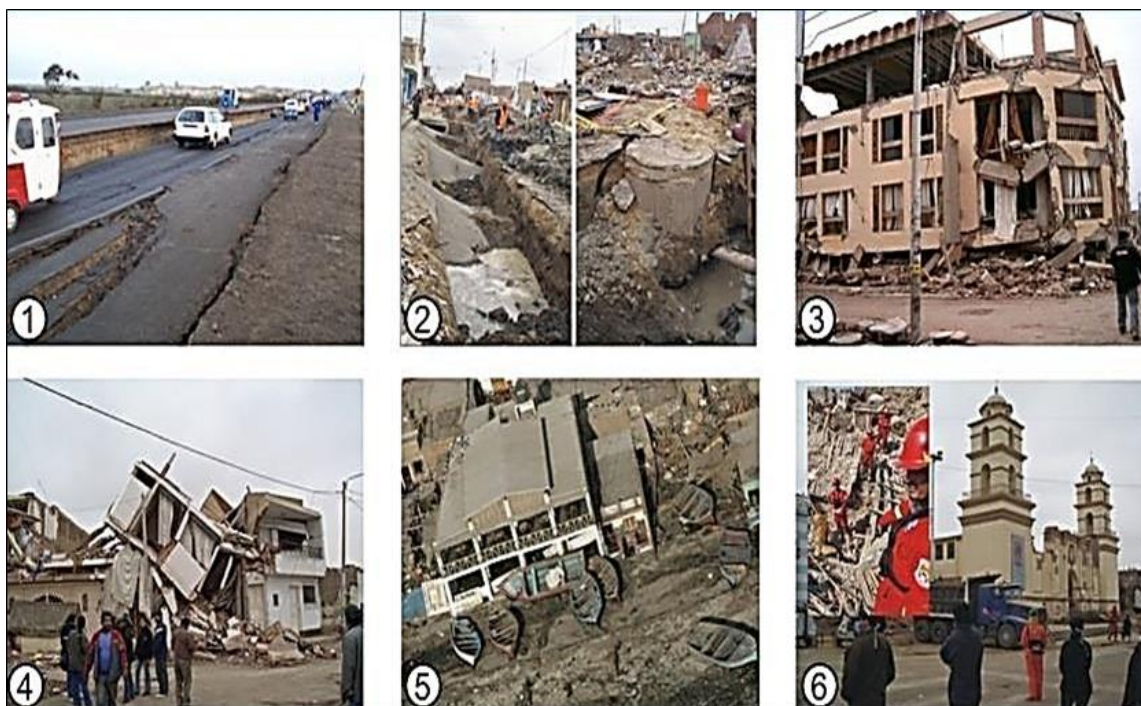
In Fig. 6, (1) shows liquefaction and lateral spread of the Panamerican Highway approaching the bridge from south to north, that crosses the Pisco river in its lower part, so it is always humid. Fig. 6 (2) shows the damage to water and sewage pipes due to the soil high seismic intensity VIII (MMI) and large soil deformations. The soil there consists of fine sand and silt with the water table near the surface.

Fig. 6. Effect of the Pisco earthquake of August 15, 2007. All photos taken by the author, except picture (5) taken by the Peru Air Force and provided to the author by INDECI.

Figs. 6 (3), (4) and (6) show the collapse of two R. C. building without seismic-resistant design, and the church of Pisco with adobe walls and its roof collapsed over members of families of some 85 persons, who perished. Fig. 6 (5) shows small fishing boats that landed in San Andres, artisanal fishing port. The tsunami wave high and inundation limit agreed with the estimation made 6 years before the 2007 earthquake and tsunami.

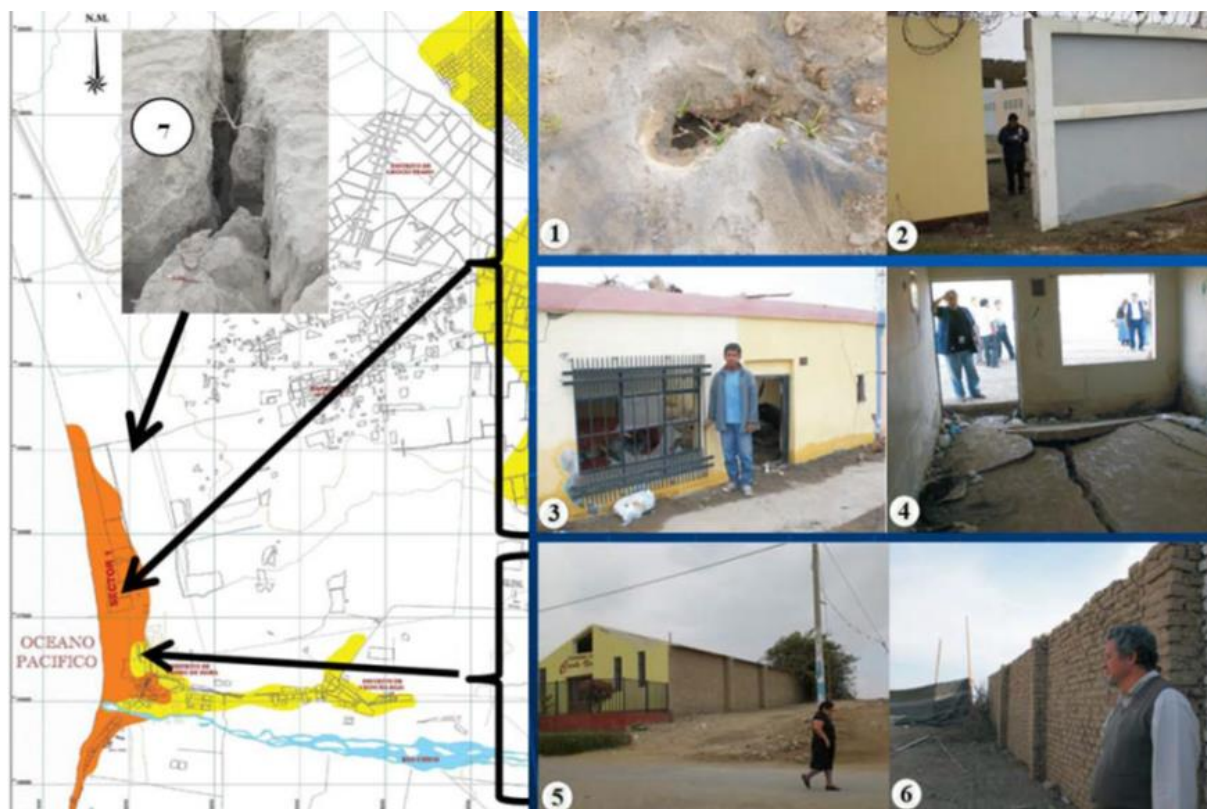
The hazard map of the locality of Tambo de Mora was developed in 2001-2002 as part of the hazard map of the city of Chincha, the provincial capital. Fig. 7 (1) shows the typical volcano of soil liquefaction that extensively occurred there. Fig. 7 (2) shows the lateral spreading of a wall at the Tambo de Mora jail. The initial clearance between two walls was only 2.5 cm (one inch). The brick house of Fig. 7 (3) and the Jail of Tambo de Mora Fig. 7 (4), both settled 0.55 m.

Figs. 7 (5) and (6) show high adobe walls with no reinforcement of a church, 4.2 m high walls and a deposit with it walls of 2.8 m high, and no roof. Both adobe constructions had no damage at all.

Why were the microzonation effects so clear in Tambo de Mora?. The lower sector of Tambo de Mora consists of fine sand and silt water saturated soil and extensive liquefaction occurred as predicted six years prior to the earthquake. The seismic intensity there was IX MMI.

Fig. 7. Microzonation effects in Tambo de Mora and photos taken in August, 2007 after the Earthquake of August 15, 2007. (1) Volcano of soil liquefaction. (2) Lateral spreading, a “door was opened”. (3) Settlement of 0.80m 1.00m. (4) Settlement of bearing walls and broken concrete floor. (5) Undamaged adobe church. (6) Adobe fence, only 200 m from the Tambo de Mora main square (Plaza de Armas) where soil liquefaction occurred. (7) Large and abundant cracks were opened north of Tambo de Mora where also a 3 km long and 0.6 km wide block was displaced a few meters toward the ocean. Microzonation map is a courtesy of INDESI. All photos are taken by the author.

The adobe constructions are built on top of a small hill that was cut, to have flat area as seen in Fig. 7 (5) and Fig. 8. Soil at that level is very dry and compact. The intensity there was less than VI MMI.

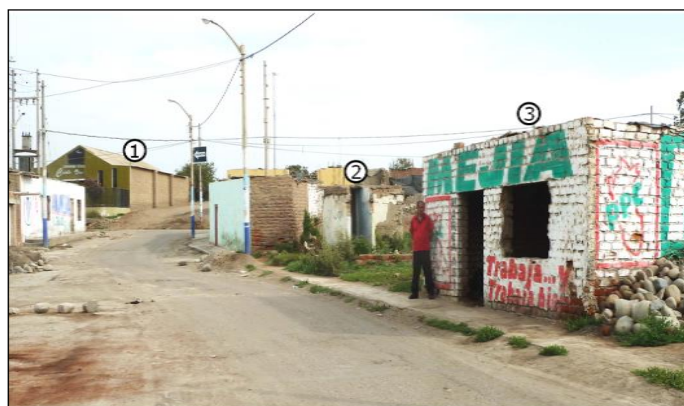
Fig. 8. Microzonation effects in a 50 m long street in Tambo de Mora. Photo taken by the author, December 2013.

Fig. 8 was taken a year ago, showing the church (1) with no damage (2) is a one story high brick construction with severe damage, and the brick house (3) settled some 0.40 m. From (1) to (3) there are some 40m. Notice that the change of slope of the street level, mark the limit between the low fine grain water saturated soil and the very dry and compact soil.

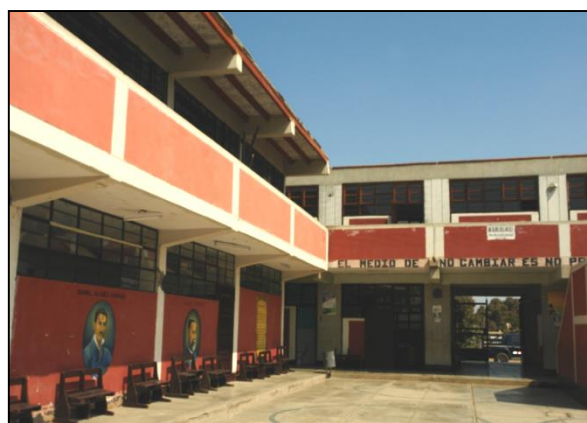
Fig. 13. Left block designed with Peru Seismic Code of 1977 and right building with the 1997 version. Photo taken by the author in Ica. September 2007.

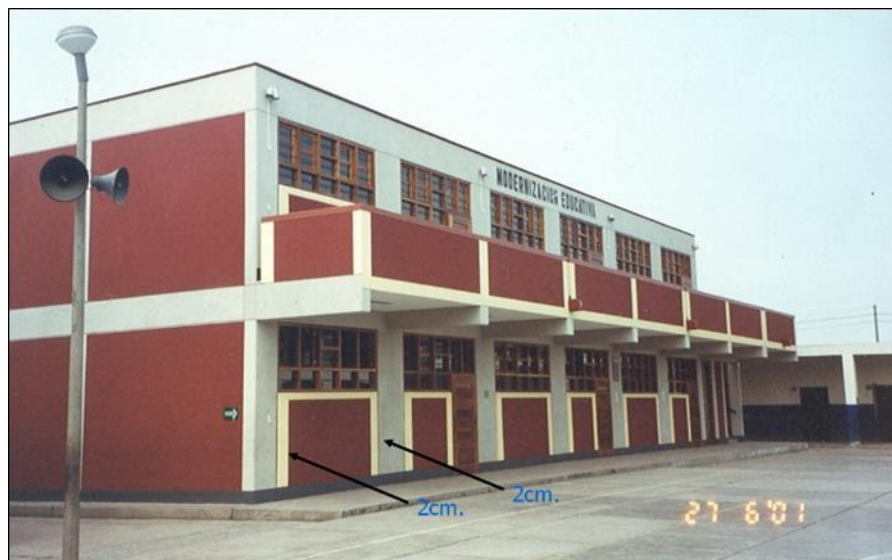
Fig. 14. Safe Peruvian school building in the Arequipa Region, Peru. Photo taken by the author, June 2001.

school buildings, due to the structural defects of short columns, as also happened during the 1990 Luzon, Philippines earthquake and the 1999 Chi-Chi, Taiwan earthquake. The Peru Seismic Code of NTE 0.30 approved by MVCS in 1997 eliminated the short column structural defect by making two small changes to the previous 1977 seismic code. The permitted lateral drift was reduced from 0.010 to 0.007 and the importance factor was increased from  $U=1.3$  to  $U=1.5$  as corresponds to essential facilities in the event of disaster. Fig. 12 shows the frequent failure due to short columns. Fig. 13 shows a school building at San José de Los Molinos in Ica affected by the August 15, 2007 Pisco, Peru earthquake. The left block was designed with the 1977 seismic code and the right one, designed with 1997 version. Fig. 14 shows a safe school building that instead of having short columns, has R. C. shear wall separated 2 cm from the filling walls. The back facade has the same design as the main one.

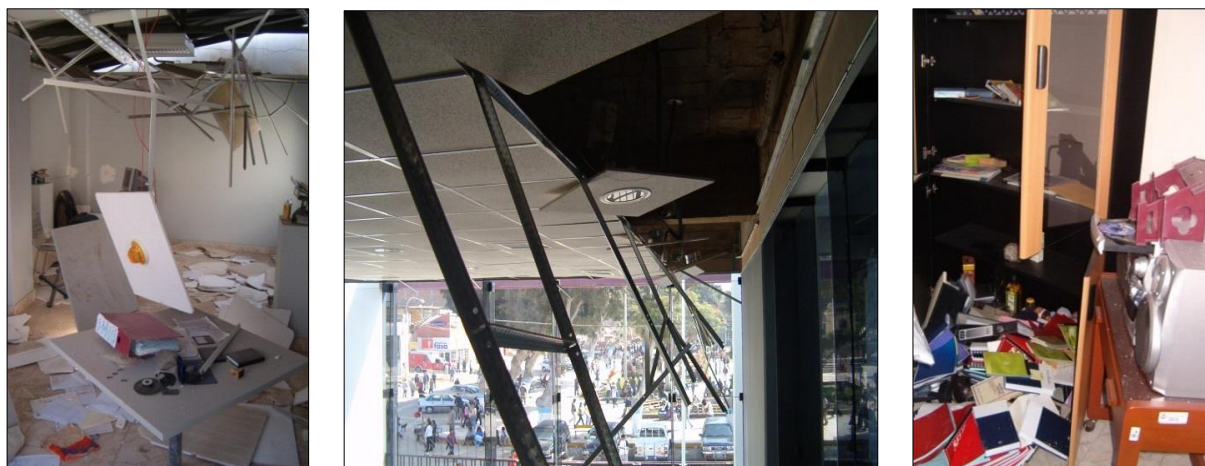
Fig. 15 shows non-structural damage and building contents in the Pisco Custom Office, a three story R. C. building, where the seismic intensity was VIII MMI during the 2007 Pisco earthquake.

Fig. 15. Three story R.C. Custom building in Pisco with non-structural damage and in its content. Photos kindly provided to the author by the administrator of Pisco Custom Office.

In Lima in spite of the distance of over 200 km from the epicenter of the 2007 Pisco earthquake, Mw 8.0 USGS, there was important damage of those types in tall R. C. building, such as the SUNAT, the tax collecting institution, a 14 story building that suffered severe damage from the 5th to 14th story. Authorities were persuaded to relocate its computer center from the 9th story to the 3rd where the non-torsional vibrations and the lateral drift are acceptable.
